## Beale Air Force Base Case Study

## Same-Day Repairs Keep Military Airfield Open

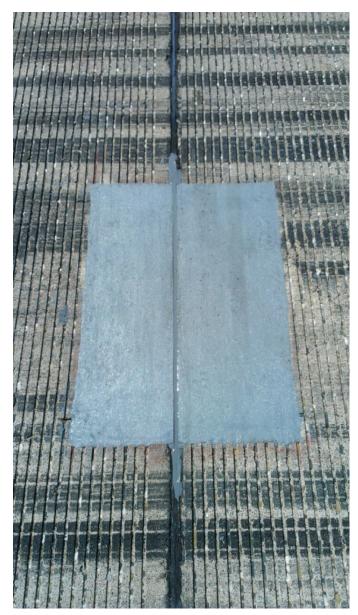
Within an hour, Delpatch™ was ready for airfield traffic.

Repairs were made in partial depths, typically 2 to 4 inches. In some areas, workers had to repair up to 9 inches. Because of Delpatch's fast setting time, the concrete had to be completely ready to receive the patch before Delpatch was mixed. Workers mixed the two-part Delpatch with a drill in 5-gallon buckets.

When fully mixed, after about a minute, workers poured Delpatch into the repair area, brought it to grade and troweled it to make it even. Within an hour, Delpatch was ready for airfield traffic, which proved essential to the military base's requirements.
